Kaspar Graf, Bernd Rathmayr, and Valentin Raemy

On December 17th 2009, a rock avalanche with a total volume of about 500 m³ occurred after heavy rainfall near the western entrance of Tempi Valley, Greece. The road was hit by rocks and boulders with a single maximum size of about 20 m³ causing one fatality. A close up inspection showed that dissected and toppled rock fragments had collapsed 100 m above the road. Apart from the tectonic predisposition, possible triggers were the absorption of infiltrating water in open joints, the possible hydraulic head in closed cracks during rain fall and the lowering of the friction angle of the material (earthfill) in the slide plane during rain storm. First response measures were carried out to secure the critical section of the rockfall incident. An instable rock mass was monitored and stabilized directly with high tensile steel netting and an adequate amount of rock bolts. Step by step, measures were then deployed from top to bottom of the site: Scaling of the uppermost transition zone, installation of a low energy barrier followed by scaling of the steep transit zone and finally scaling of the lowermost slope zone. As a permanent and long t

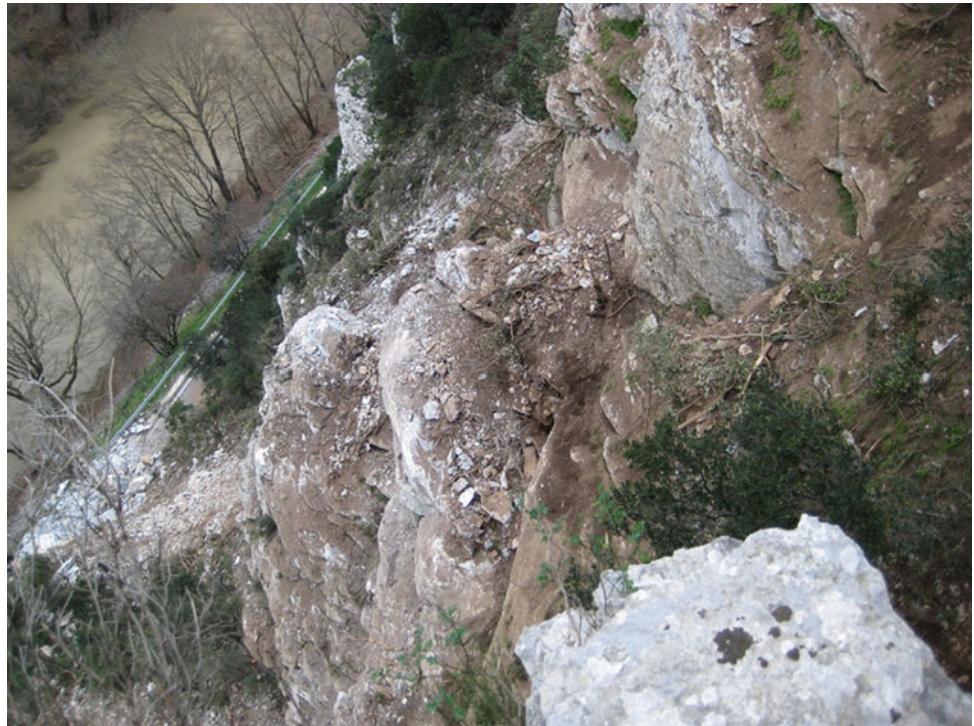
Fig. 365.2 View of the transit zone of the event of December 17 2009 from the source zone (GEOTEST 2010)

The transit zone was covered by a thin soil cover, in many areas the limestone crops out. Fragmentation upon impact on the rock surfaces was intense as shown by the abundant small rock splinters that were strewn across the zone of impact. Bushes were completely uprooted and crushed (see Fig. 365.2).

From the observations made during the site inspection (Fig. 365.2) and the course of events before and during the rockfall, it is possible to deduce some important triggering

factors including the overall tectonic predisposition, a long term destabilization along main tectonic lineaments (toppling etc.), the loading of K1 joints with earth material and the entering of roots in cracks. The event's initialization may have happened due to the absorption of infiltrating water by the earth backfill resulting in additional loading and lowering of the friction angle and a possible hydraulic overpressure in closed cracks during rain fall.

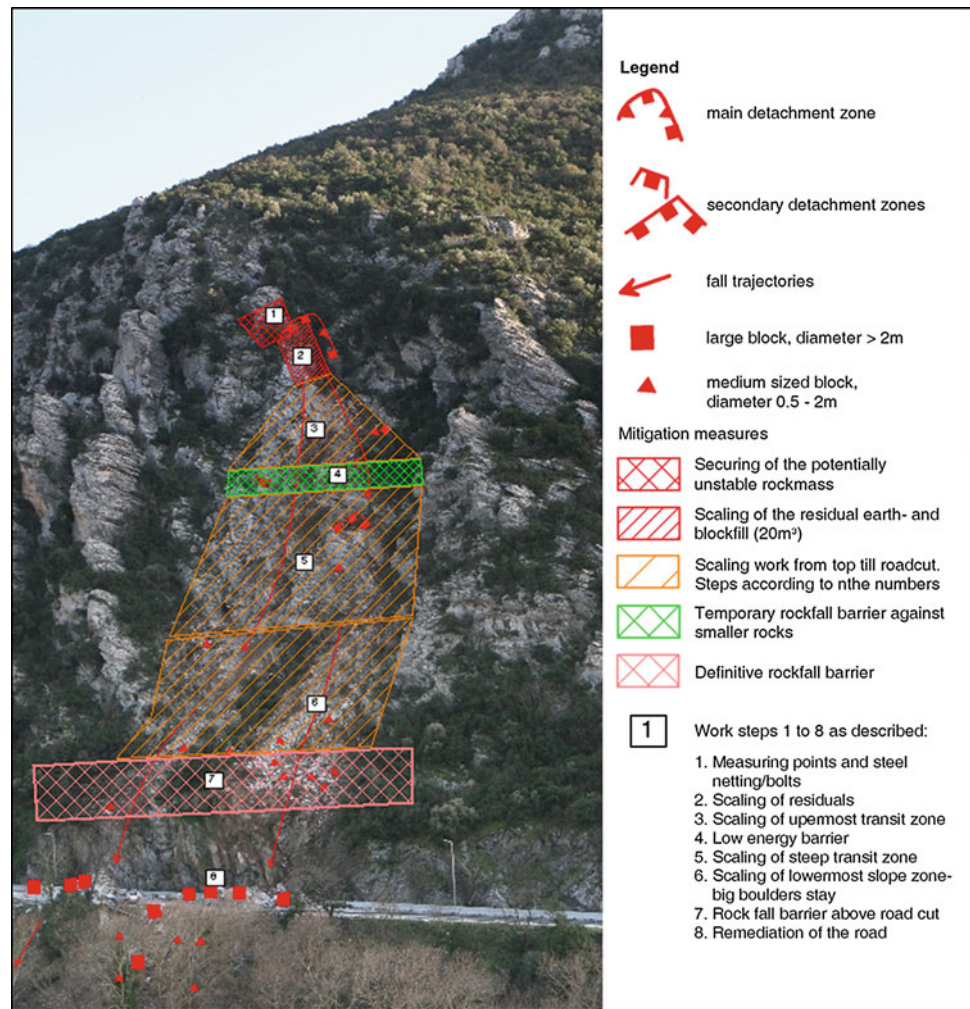
Fig. 365.3 Mitigation of the rock avalanche in Tempi valley (GEOTEST 2010)

Rockfall simulation was carried out with a specialized model (Krummenacher et al. 2007). A high resolution digital terrain model was used. A predefined number of blocks were simulated to obtain results within a statistical range. The results showed that a rockfall barrier with energy absorption of 1000 kJ and a height of 3 m could protect the entire length of the affected section (GEOTEST 2010). First response measures were carried out to secure the critical section of the rockfall incident area. Measures were deployed from top to bottom according to Fig. 365.3. Design of measures was based on an existing design but adapted to new findings of the field investigation (GEOTEST 2010). A survey flight by helicopter of the rest of the southern side of the gorge revealed a number of Special Focus Areas (SFA). The inspection concentrated on natural outcrops above the road (GEOTEST 2010). Periodic inspections are carried out in order to monitor rockfall hazard (GEOTEST 2010).
