Monitoring of Tempi Valley Critical Rock Masses: Establishment of Special Monitoring Network and Procedures in Aegean Motorway S.A. Concession Project

Kostas Kalogirou¹, Efstratios Iliaskos²

¹Technical Director at Aegean Motorway S.A. Concession Company, Moschochori 41500 Larissa Greece, (kkalogirou@aegeanmotorway.gr)

²Tunnel and Pavement Project Engineer at Aegean Motorway S.A. Concession Company, Moschochori 41500 Larissa Greece, (eiliaskos@aegeanmotorway.gr)

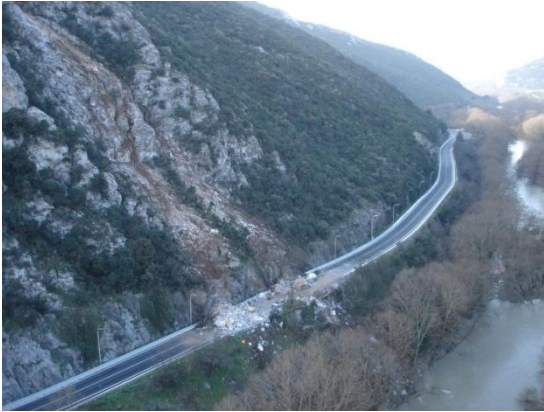
Figure 1. Tempi Valley rockfall 2009 by helicopter

Horio of Evritania region in 1963 that led to loss of 13 human lives and buried a whole village, the Panagopoula landslide in 1971, Tempi Valley rockfall in 2009 as presented in figure 1 & 2 that led to loss of a human life and the closure of the national road Athens – Thessaloniki for approximately 4 months, the Santorini rockfall in 2011 with one human loss, and many others.

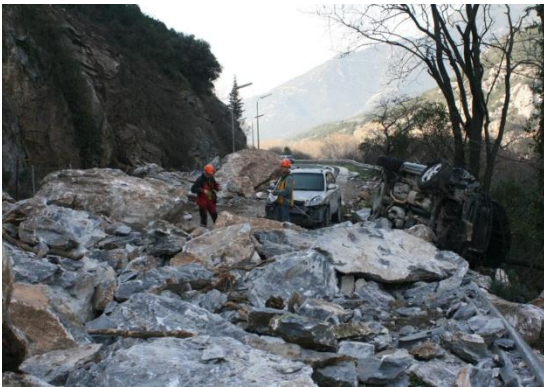
Figure 2. Tempi Valley rockfall 2009

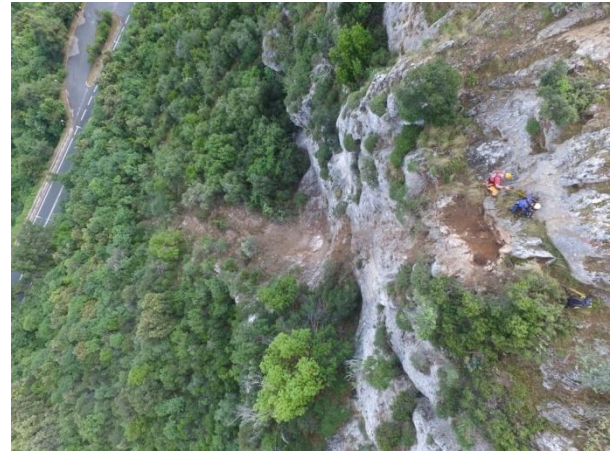
Figure 4. Inspection and scaling works

All parts of the barrier systems have to be controlled according to the maintenance manuals of the manufacturer. If parts of the system are damaged the diminution of the protection properties has to be evaluated and if necessary, immediate measures have to be taken. In case of damage to any of the rockfall protection measures, the damage report sheet has to be completed. In this sheet, damages to the rockfall protection are described, documented and classified with respect to the severity of the incident. The induced and finally completed measures are documented. Inspection and maintenance activities are presented in pictures 4 & 5,

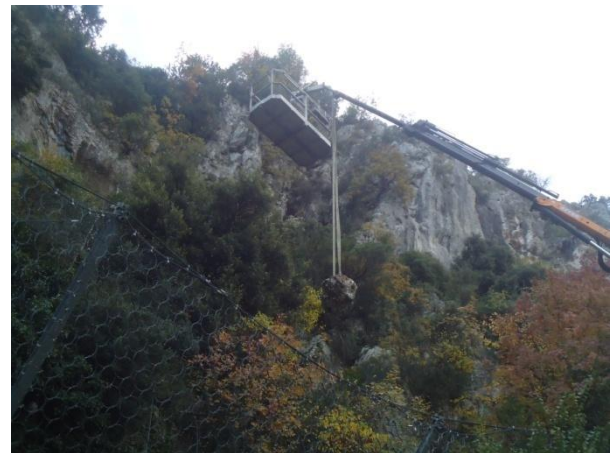
Figure 5. Emptying of barrier from trapped blocks

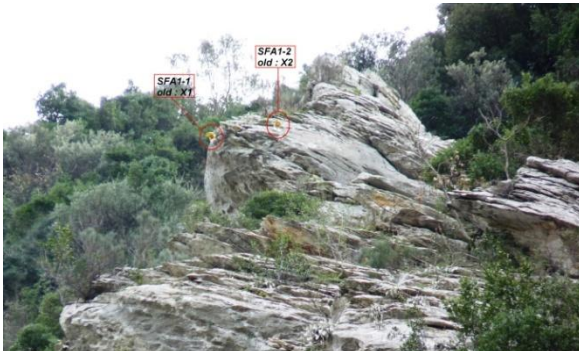
Figure 6. Prisms installed in special focused area SFA1.

Figures 6-8 of the installed geodetic network are presented below.

Prisms are mainly installed in special focused areas (SFAs). Monitoring is performed at least once per month and always after an extraordinary situation like

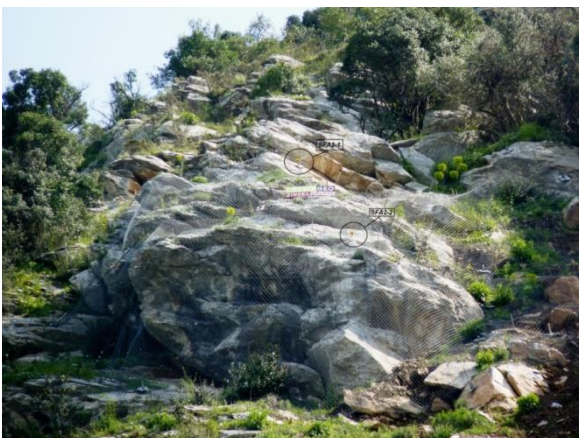
Figure 8. Prisms installed in special focused area SFA2.

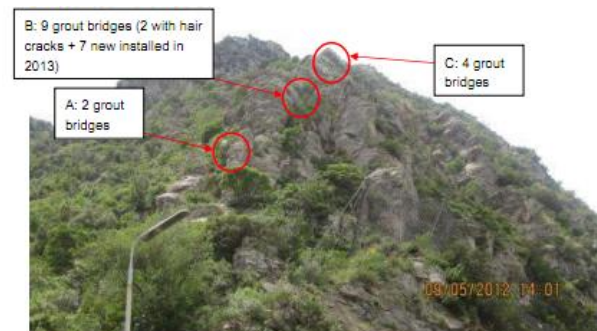
Figure 10. General View of the installed grout bridges at section 6 (old chainage 386+650).

Moreover to the geodetic monitoring network, another network consisting of grout bridges is applied to rock discontinuities where movement is supposed to occur prior to failure (figures 10 & 11). Cracks in the grout bridges would indicate movement. In total almost 100 grout bridges have already been installed in Tempi Valley in various locations.

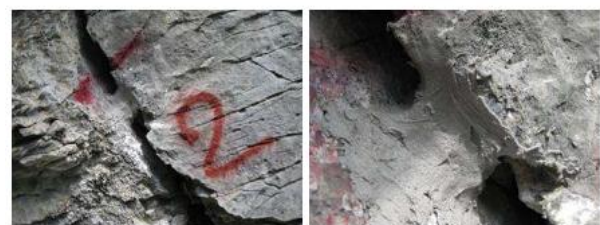
No 2A
Installation Date: May 2012 (3rd bi-annual inspection by GEOTEST _ installation by Greek Alpinists)

Figure 11. Detail of grout bridges

Details of the condition of all grout bridges are recorded in designated forms and evaluated. Condition of each grout bridge is compared with the initial condition right after its installation. A general rule is the installation of more than one grout bridges per
